Guidelines for Rehabilitating Buildings  
at the Presidio of San Francisco

*Prepared by  
Architectural Resources Group  
San Francisco, California*

*for  
Presidio Project Office, Golden Gate National Recreation Area  
Denver Service Center  
National Park Service  
U. S. Department of the Interior*

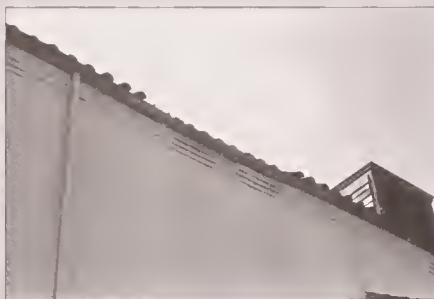
*Built-in gutters are particularly vulnerable to deterioration. Because they are within the roof or wall structure, their deterioration can go unnoticed until it leads to serious problems, such as rotting wood.*

Inspect built-in gutters frequently; they are vulnerable to leaks due to building movement. Patching should be done when necessary with an appropriate, flexible, UV-resistant material. Asphalt patches should be removed and proper repairs made.

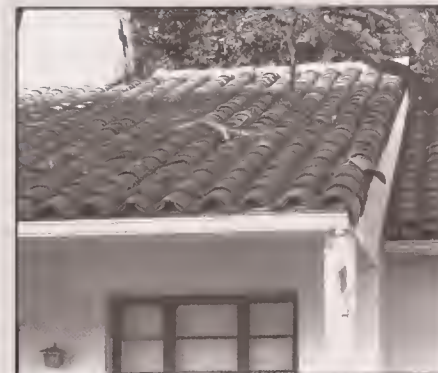
*Clay tile roofing, while very durable, may be damaged due to impact or deterioration of substrate and fasteners. This roof can be preserved by repairing its substrate and fasteners as needed, and by selectively replacing damaged tiles.*

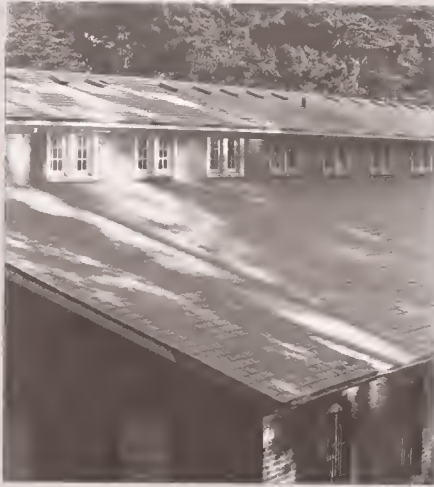
*The roof on this stables building was recently restored to its original slate finish. The roof monitor retains its original operable windows, which provide both light and ventilation for the interior. Copper gutters and downspouts were also restored.*

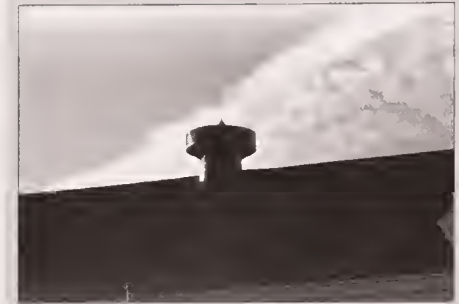
*Early ventilators such as the one shown above were modest in scale and often custom-designed to enhance the roofscape. Newer rooftop ventilating equipment is frequently larger and designed with little attention to a particular building's historic appearance. Nonhistoric equipment should be placed in inobtrusive locations.*

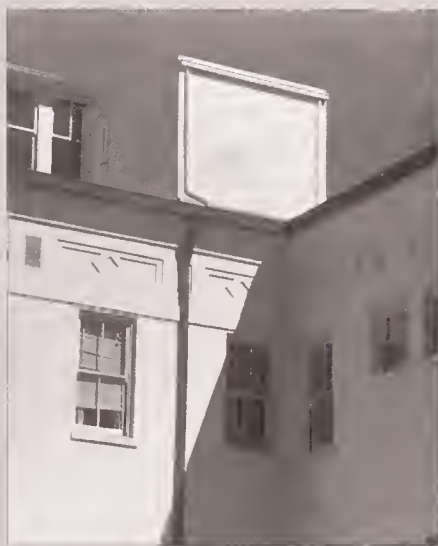
*This rooftop addition is visible from several vantage points and also obscures a historic window. If rooftop structures are necessary to accommodate elevators, stairs or mechanical equipment, they should be carefully designed and placed as inconspicuously as possible.*

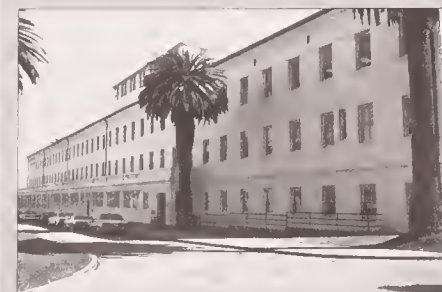
*Most Presidio buildings, regardless of size and use, are characterized by regular, simply ornamented fenestration. Double-hung wood windows are the most common type.*

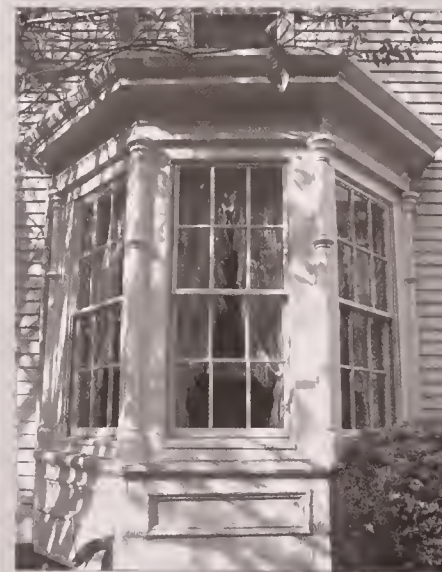
*This bay window is an example of one of the more ornamental fenestration elements at the Presidio. Its six-over-six sashes and slender muntins are typical of early windows at the Presidio.*

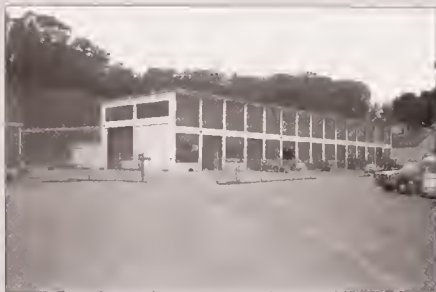
*Steel industrial sash is the second most common type of fenestration at the Presidio. Buildings such as this one benefited from the quantity of natural light allowed by the large expanses of steel-framed glazing.*

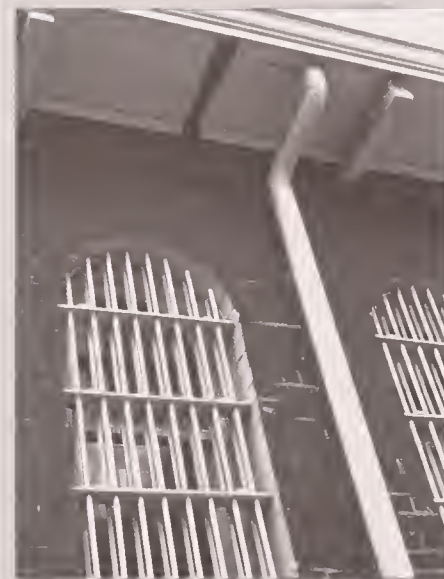
*Sometimes significant window features, such as these double security bars, should be preserved even when the building's new use does not require them or might benefit from their removal (more natural light, improved view, etc.).*

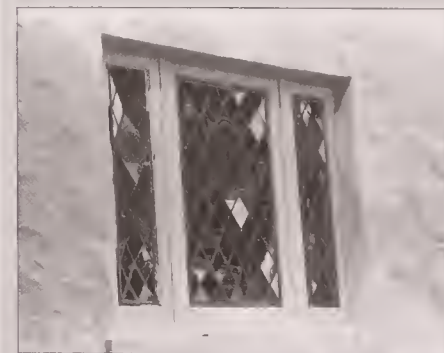
*The Presidio's few examples of historic, character-defining decorative glass, such as the leaded glass window above, should be preserved in place.*

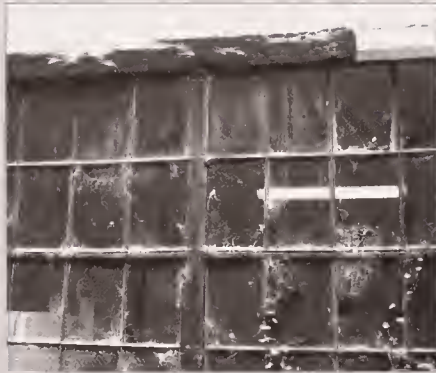
*The windows of some utilitarian buildings have not been maintained as well as those of more important structures. The water-caused problems seen here—corrosion of steel, spalling of surrounding material, damage due to vegetation—are typical in less prominent locations.*

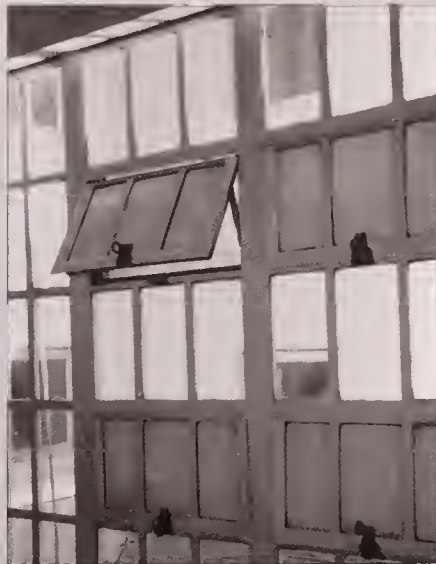
*Some glazing has been painted for daylight control. The use of shades, curtains, or other removable devices is preferred. Maintenance of historic hardware in operating condition is also important.*

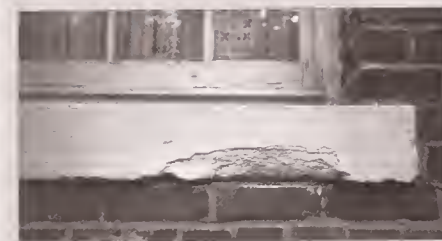
*The accumulation of water on a sill is one of the primary causes of window deterioration. Modifying the sill's design by sloping it and adding a drip cut along its lower edge will frequently solve the problem. When damage has extended up into the frame or sash, repair or replacement of the window component may also be necessary, though the entire window may not need to be replaced.*

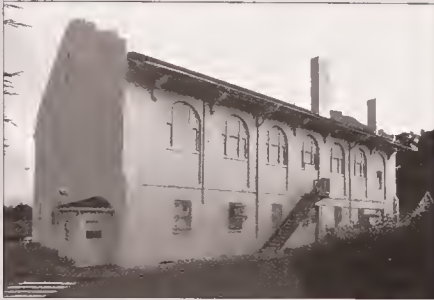
*Windows have been painted over to accommodate the needs of building occupants. This may result in negative, long-term irreversible effects; interior blinds or shades can be used effectively to limit the entry of natural light when necessary. Note also the many undesirable window modifications seen on this facade.*

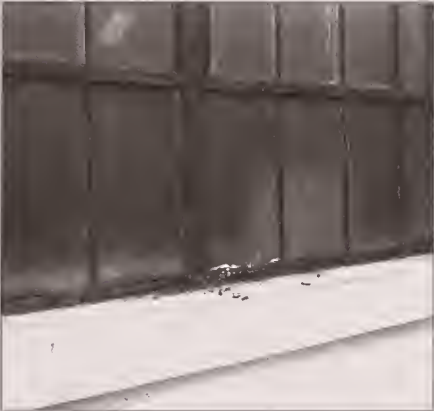
*A poorly detailed sill has allowed rainwater to collect and severely corrode the bottom of this steel window. The deterioration probably extends through to the interior. Extensive repair or replacement of part or all of the sash and frame will be required.*

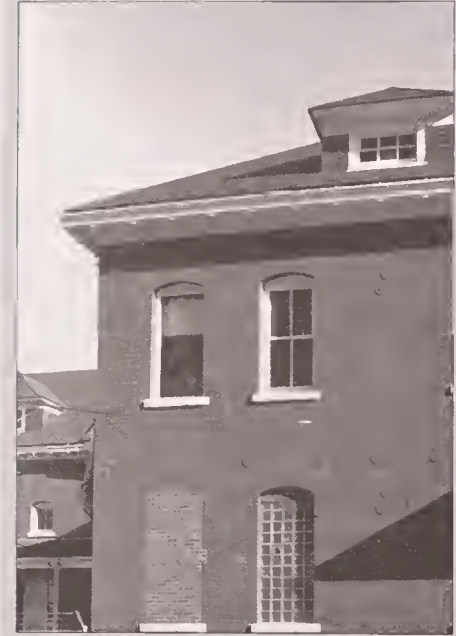
*This building has several altered windows. Because the building is one of a group of similar buildings, and there is clear evidence of the original window style, form, materials, and color, reconstruction of the altered windows is appropriate.*

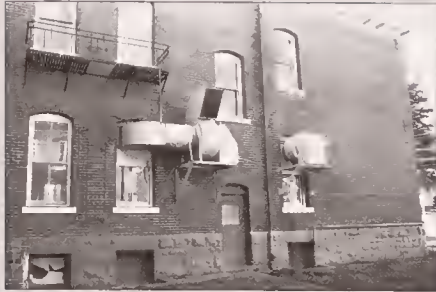
*The location of functions within a building should be carefully planned with respect to necessary ventilation and other equipment. It is preferable to use existing openings for penetration. Windows may be used if original sashes are retained; however, in the building shown above the mechanical ductwork is obtrusive, poorly integrated, and damaging to the historic windows. Although located on the rear facade, this work is highly visible, and considering the building's significance, it is an unacceptable alteration.*

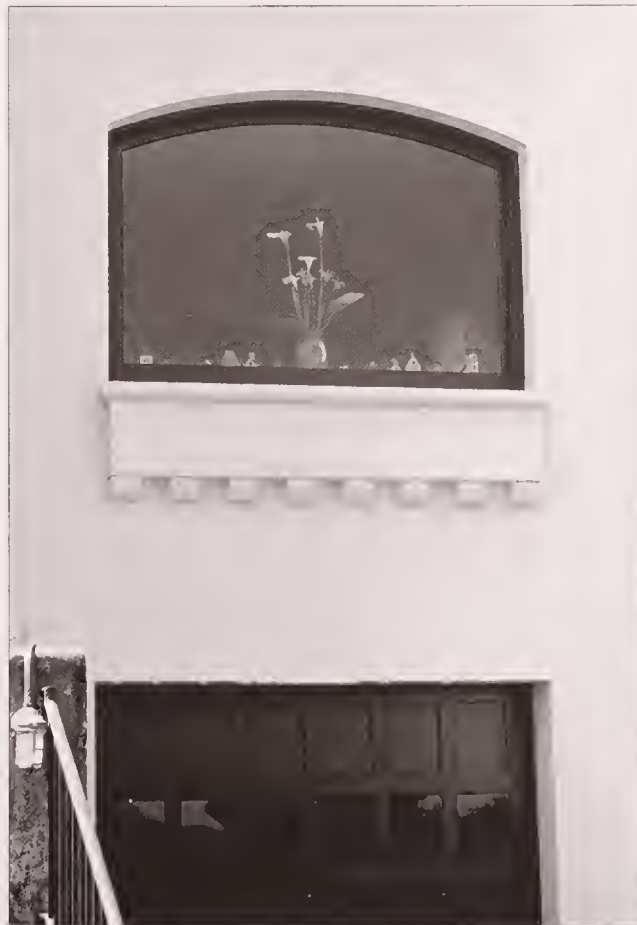
*Although not a frequent alteration at the Presidio, some multi-paned windows have been replaced with fixed, single-pane windows. When replacement is necessary, either the original window should be duplicated or a reasonable facsimile should be used, with the approval of the National Park Service.*

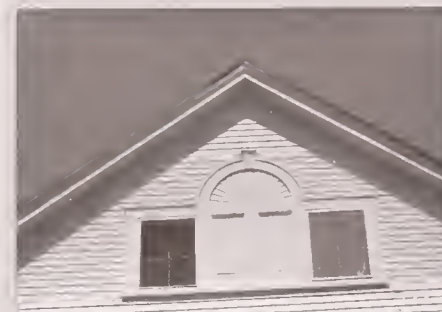
*The insect screen on the right window above obscures the window muntins and eliminates the pattern of light and dark, flattening the facade's appearance. When needed, screens should be divided to match the windows, and recessed if possible.*

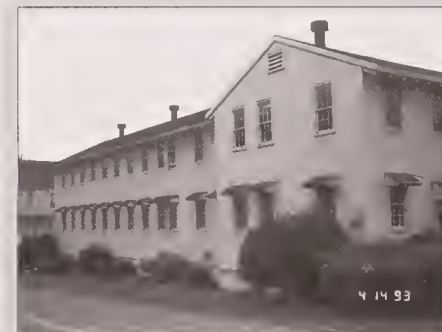
*The awnings on this simple building serve to limit heat gain. A similar solution may be appropriate for some Presidio buildings, but such action should only be considered after evaluating its historical appropriateness.*

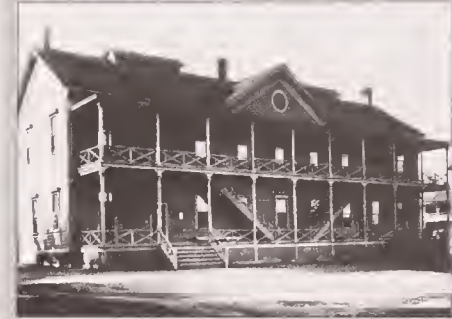
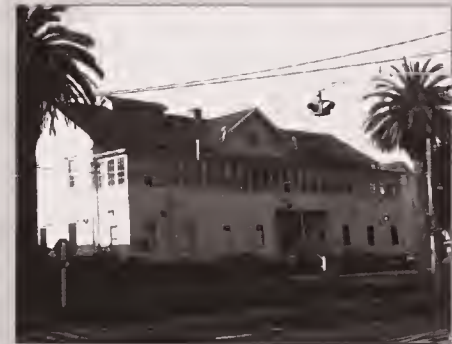
*Many porches have been partially or fully enclosed to shield against the weather or to gain floor area. These two photos of the same building illustrate how a building's historic character can be completely changed by such alterations.*

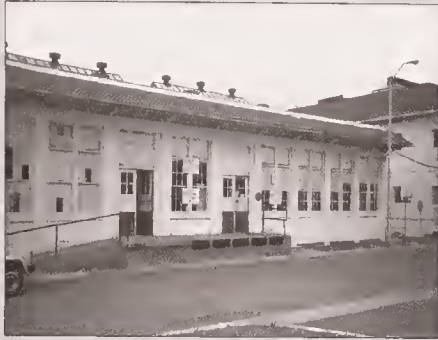
*This building has many of the typical utilitarian features: shed roof, double swinging doors, and ramped loading dock fronting directly on the street.*

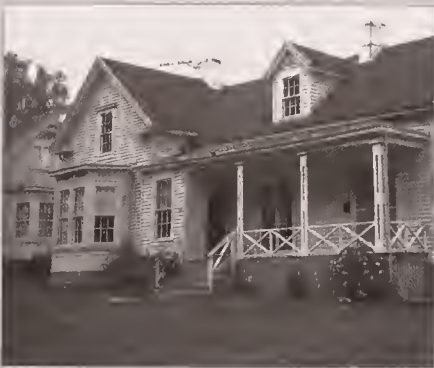
*The delicate detailing of the porch roof support posts is typical of the early residential buildings at the Presidio.*

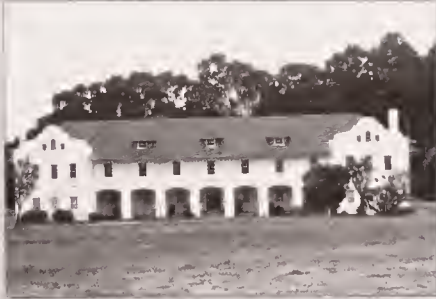
*Mission Revival porches tend to be recessed into the building envelope. The strong play of light and shadow and the rhythm of arches are primary design features.*

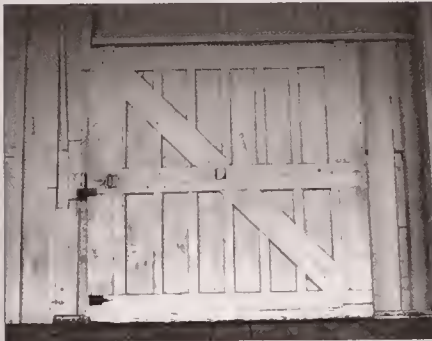
*The warehouse buildings have large, rolling doors which are character-defining features and should be retained. They should continue to be used as service doors, or with a new occupancy, they might become nighttime "shutters" over large glazed openings.*

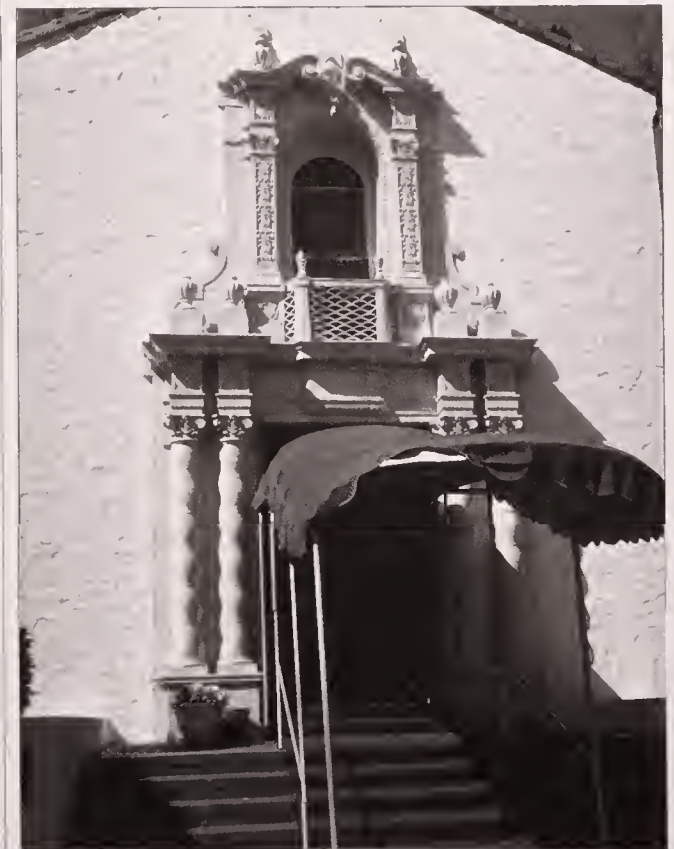
*An inappropriate modern addition, such as this awning, should be removed. It obscures the highly ornate, terra-cotta door surround, an important character-defining feature of the building.*

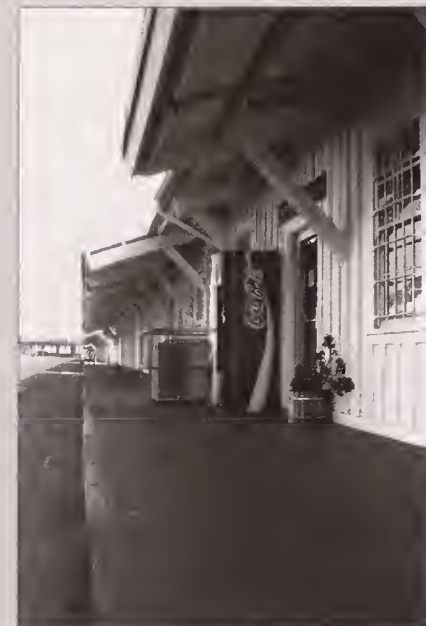
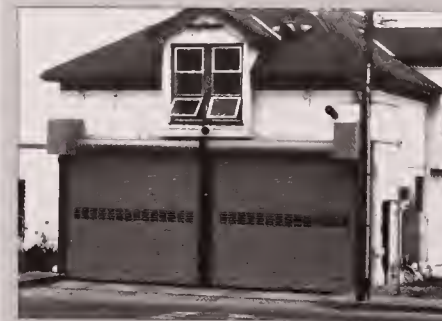
*The loading docks at the wood warehouses shown above function as elevated walkways. The placement of the plant, vending machine, and air conditioning unit intrudes on the walkway and diminishes the building group's character. The photo below illustrates the negative impact of new overhead metal doors on a historic building.*

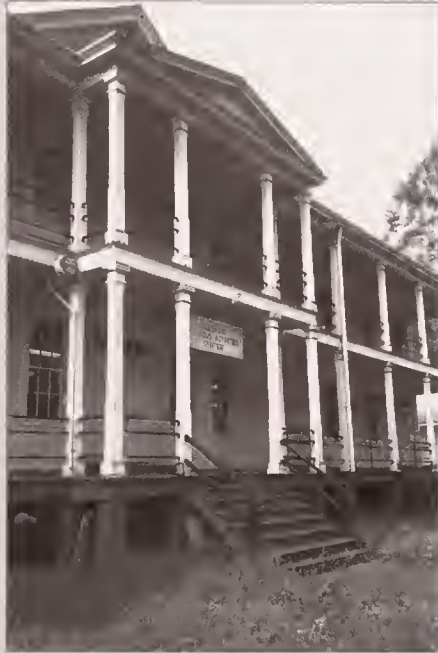
*Due to easier vehicular access to the rear of this building, its grand front porch no longer serves as the primary entrance. It is important to restore and maintain the front porch and entrance and to consider ways to reestablish its use.*

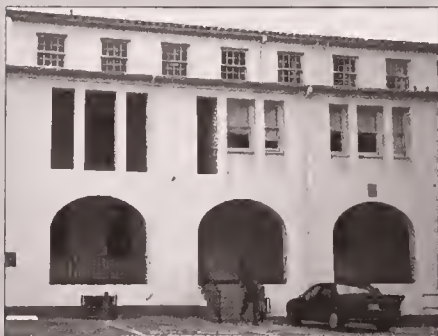
*The second-floor arcade has been partially enclosed with new infill set back from the wall, helping maintain the original solid and void pattern of the facade. However, the type and size of windows is inappropriate.*

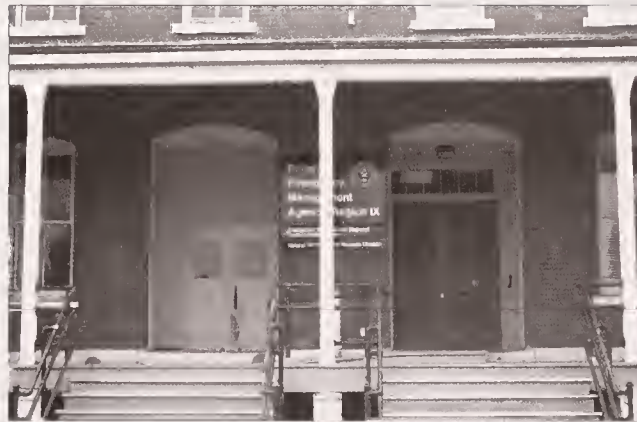
*In the building above, the entrance on the left has been extensively and insensitively remodeled. The size, scale, materials, color, and details are all inappropriate. The entrance on the right is a replacement modelled on the original drawings, but has had intrusive elements added. Care should be taken when selecting hardware, signage, lighting, and security equipment.*

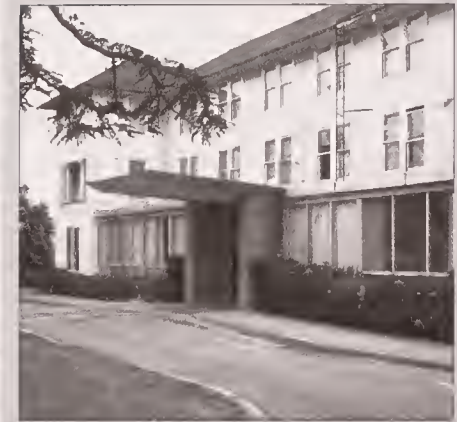
*The incompatible new entrance, above, designed for auto access, does not respect the style or character of the original building. Its scale and materials are also inappropriate.*

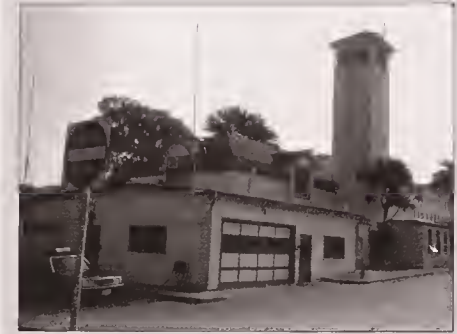
*Additions to this firehouse were built onto the original structure without regard for the original style or materials, obscuring significant detailing (the additions themselves have exteriors of different materials). Their placement in relation to the existing building appears unplanned as well.*

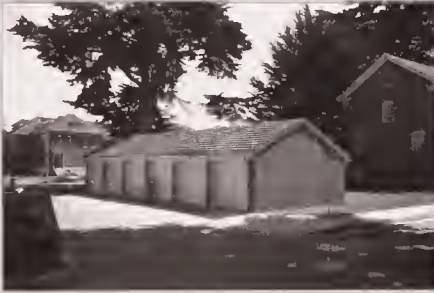
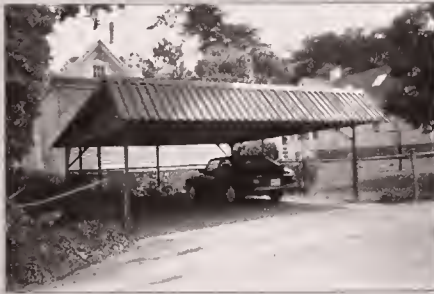
*Early garages and utility structures at the Presidio were designed to be compatible with the buildings they serviced. Roofs were of like materials and normally followed the same lines. Shown below is a carport whose shape and materials do not relate to the context. In its relatively prominent location, it is an example of an entirely inappropriate design.*

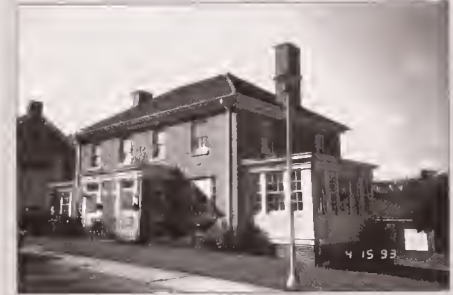
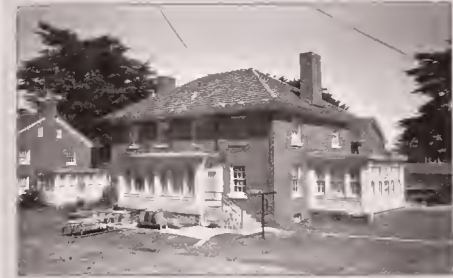
*The relationship between small wood and brick wings and larger structures, as shown above, can be used as an example for the design of new additions. Materials, massing, and forms are all used to subordinate the wings to the main building.*

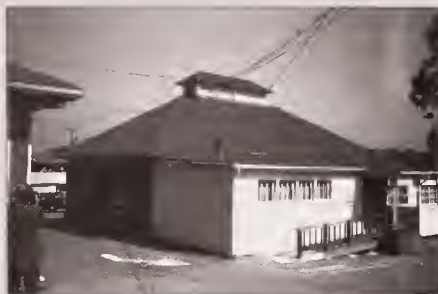
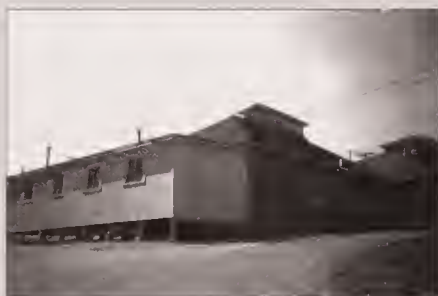
*These two views of the same building show an addition inappropriate in scale, fenestration and connection to the existing building. Note also how the change in grade can affect the appearance of the new addition, especially if it is handled as an afterthought.*

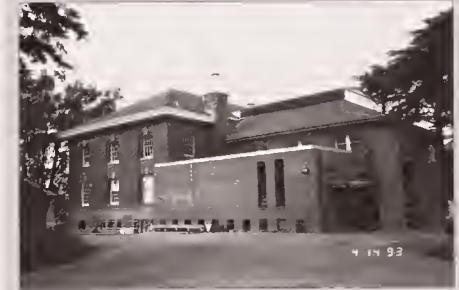
*This addition, although brick like the original building, has not maintained the rhythm and proportions of the original facade. The fenestration design is especially insensitive. The massive addition on the inside corner overwhelms the original structure and inhibits the perception of the original massing.*

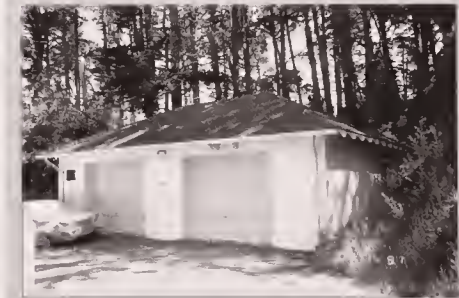
*Small mechanical enclosures designed as detached additions similar to existing garages may provide the best location for new mechanical equipment if louvers are used instead of overhead doors.*

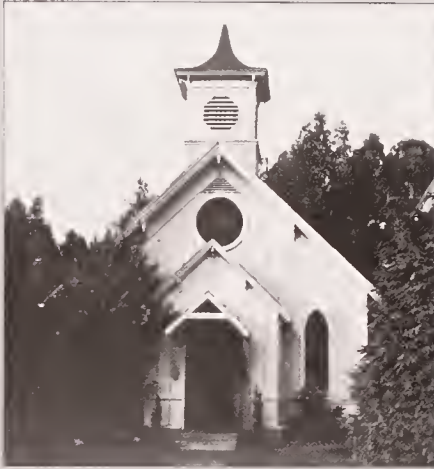
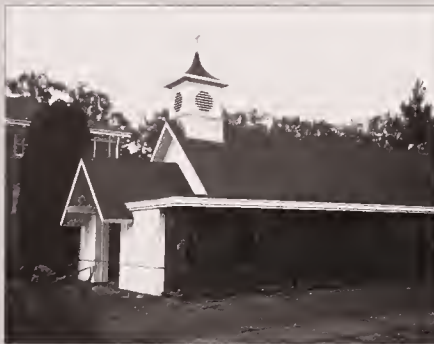
*Shown above, the design of the original chapel is contrasted with the present configuration. This is an example of an especially sensitive building form, and the addition has compromised the traditional massing and character of the chapel's interior and exterior. Interestingly, the materials and window treatment exhibit an attempt at good design that might have been appropriate in an addition to another building type.*

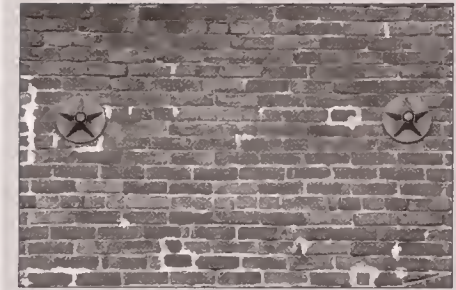
*Historic buildings frequently have rafter ties, bond iron ties or other elements which improve their seismic capacity. A building should be carefully researched and surveyed to locate these elements, and the seismic analysis should take their value into account.*

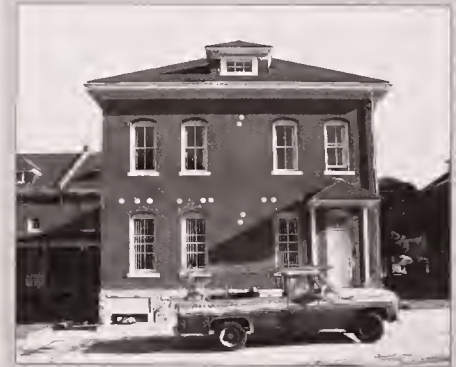
*Bolting of floor and roof diaphragms to masonry walls is an essential element of a seismic hazard reduction program. Care in location of bolt plates is important to prevent a haphazard appearance. In visually sensitive facade areas, grouted bolts should be used instead of through-bolts, to eliminate the need for surface plates.*

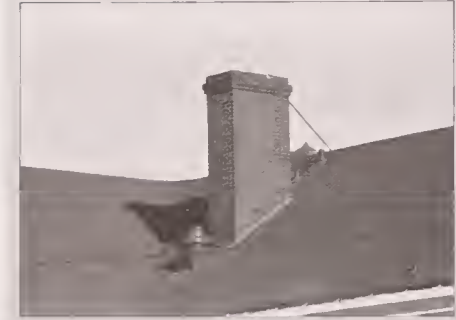
*Projecting chimneys are the most prevalent seismic hazard at the Presidio. The Army braced many chimneys. This brace provides a good example for others, with a fairly unobtrusive strut to the roof in the weak (short) direction of the chimney connected to a steel collar at the top of the chimney. Bracing chimneys in place is preferred over constructing new reinforced chimneys to match, or removing chimneys without replacement.*

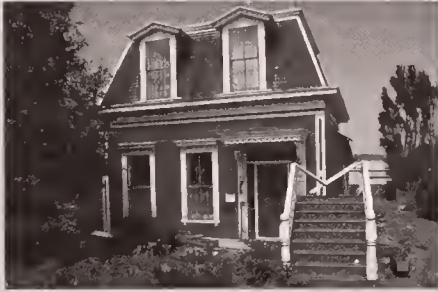
*Shown above is a typical wood-frame structure in Ferndale, California, after the 1992 Cape Mendocino earthquake. Because the post and beam structure under the house failed completely, the walls and roof superstructure dropped to the ground. Investigation and strengthening of the existing substructure bracing is important for Presidio wood-frame structures.*

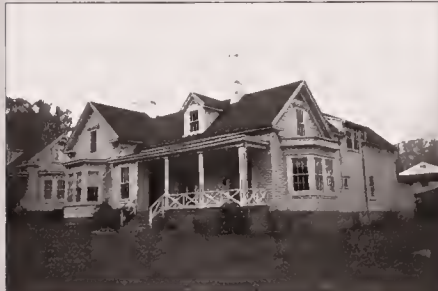
*Wood-frame residential structures, although generally not considered seismic hazards, frequently have very limited lateral support between the first floor and the foundation, often resulting in failure in even moderate earthquakes. Strengthening braces can be added very economically, but should be detailed in such a way that the exterior siding and trim retain their appearance.*

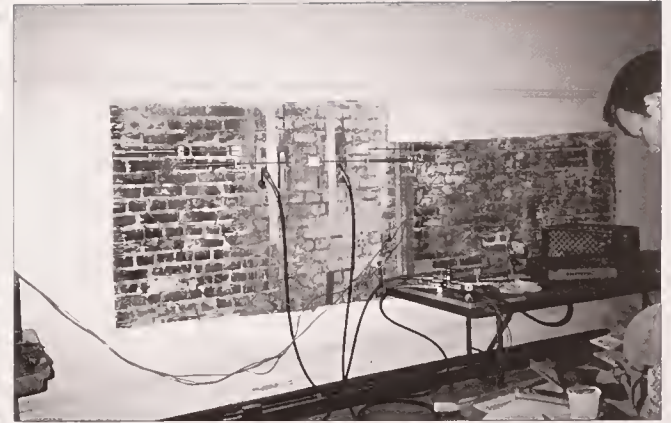
*A careful program of in-place testing is essential to the process of evaluating the building's seismic capacity. Illustrated is a masonry push-test involving two hydraulic jacks to estimate the shear capacity of the wall. Locations of tests should be chosen carefully so that the character-defining historic fabric is preserved to the greatest extent possible. Replacement of damaged brick should be performed by a mason skilled in matching the appearance and strength of the wall, rather than by the test technician.*

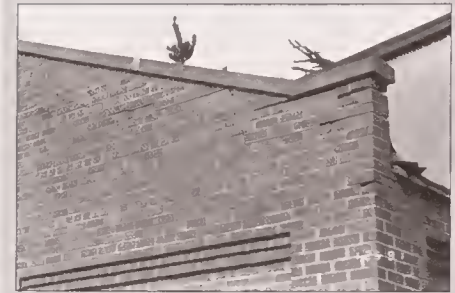
*Unreinforced masonry parapets present seismic hazards independent of the basic building structure. Strengthening measures should be concealed behind the parapet or within the wall.*

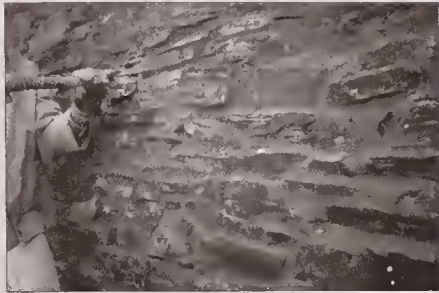
*Internal grouting of rubble masonry walls can greatly improve their seismic capacity without changing the appearance of or demolishing interior historic fabric. Care in developing a grout mix which does not damage the wall is an important element of this alternative procedure.*

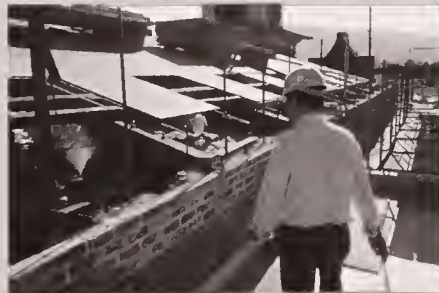
*Core drilling of masonry walls is a method for increasing the tensile capacity of a masonry wall without visual impact on either the exterior or the interior surfaces of the wall. It involves drilling 4 inch-diameter vertical cores in the masonry wall, then installing grout and rebar. It may be appropriate in areas of significant interior historic fabric. As a strengthening method, core drilling is still relatively new. It is not a reversible system and should only be used with great care and with the approval of the National Park Service.*

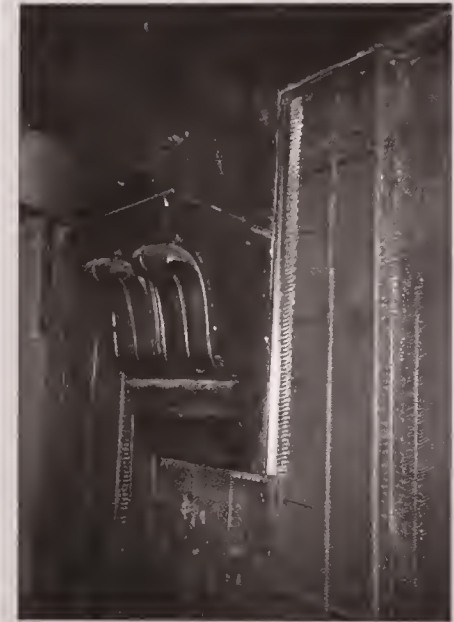
*Structural interventions, if carefully designed and coordinated with the architect, can frequently occur adjacent to historic fabric without necessitating total removal or demolition. Shown is a concrete shear wall which has been installed behind an existing hand-painted plaster ceiling and corbel beam.*

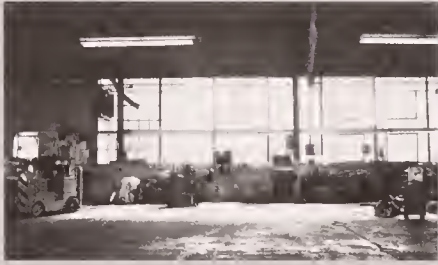
*Interiors of industrial structures are very appropriate settings for exposed bracing or tie-rods and connections. Consider subtle methods to distinguish new structural materials from the original ones.*

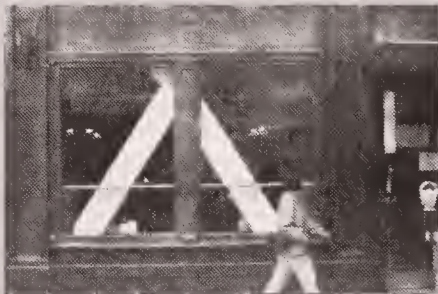
*Steel braced frames should be located carefully, so that they do not obscure windows or change the exterior appearance of the building.*

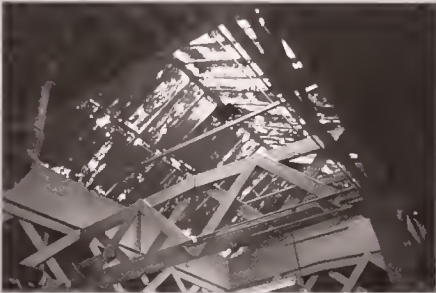
*The interiors of shops and warehouses are usually open, unadorned spaces with exposed structural elements. While this type of space could be put to a variety of uses, the generous floor-to-ceiling height, exposed truss system, and natural lighting from roof monitors (or skylights) are important character-defining features which should be retained in the rehabilitation process. In this example, the skylight was painted over.*

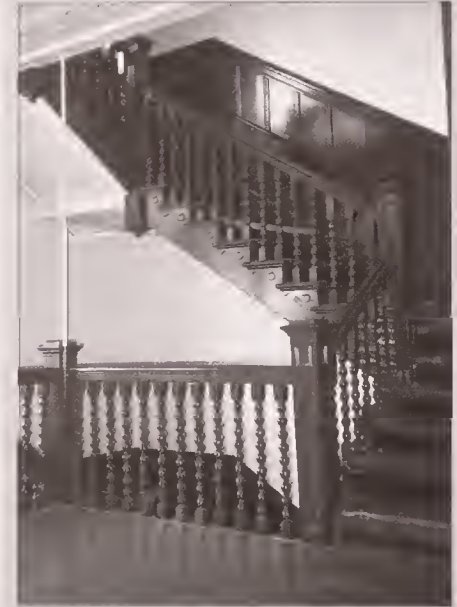
*Open stairways are an integral part of many Presidio interiors. If a second means of egress is required, consider constructing new stairs in secondary spaces. Fire-retardant coatings such as intumescent paints, fire suppression systems such as sprinklers, and the construction of glass enclosures can in many cases permit retention of stairs and other character-defining features.*

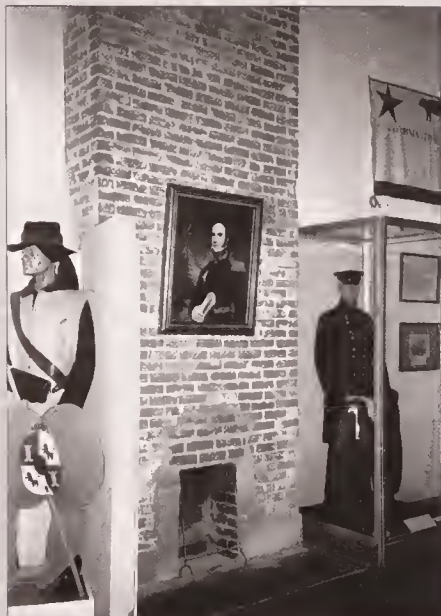
*During an earlier remodeling project, historic plaster was removed from interior perimeter walls, exposing the brick. When finishes are removed from historic masonry walls, historic finish is lost, and the exposed unfinished walls give the interior an appearance it never had historically.*

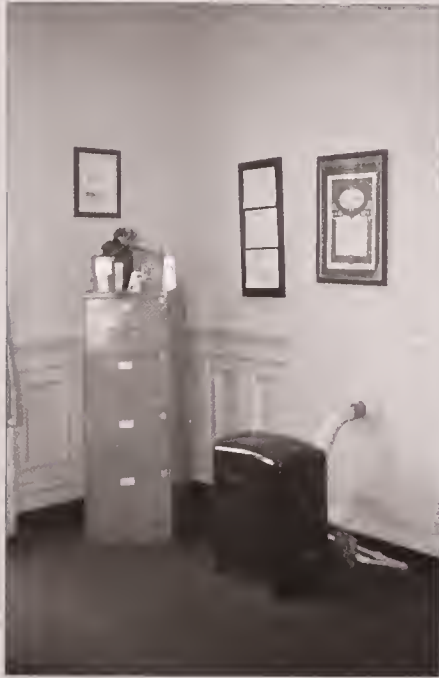
*Fragments of a historical interior sometimes remain when most of the features have been destroyed by past alterations. The intact portion could be used as a model to replicate the missing parts and restore the original interior. Here, some wainscot was removed when the gas heater was installed, but could be replaced using the remaining wainscot as a reference.*

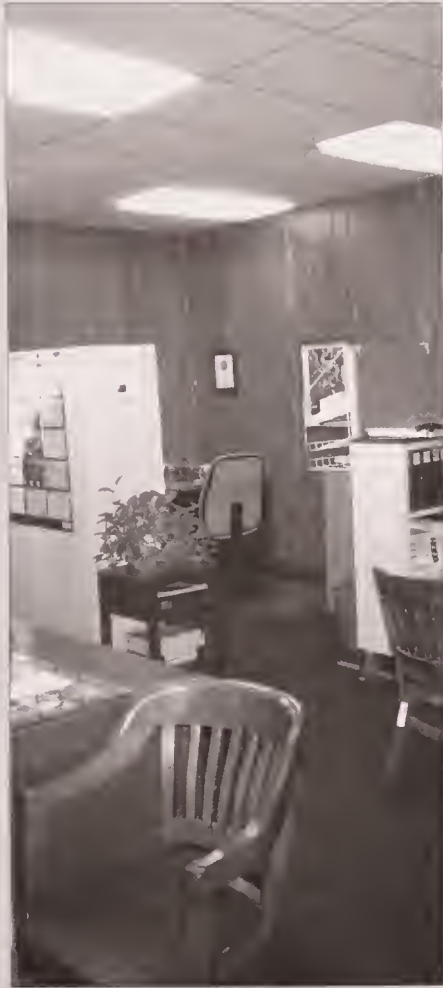
*Furring walls and suspending ceilings for the sole purpose of hiding ductwork, wiring or insulation, can change a room's proportions and can also destroy or obscure significant decorative detailing. Original features probably remain beneath the ceiling, panelling, and flooring shown above and could be rehabilitated.*

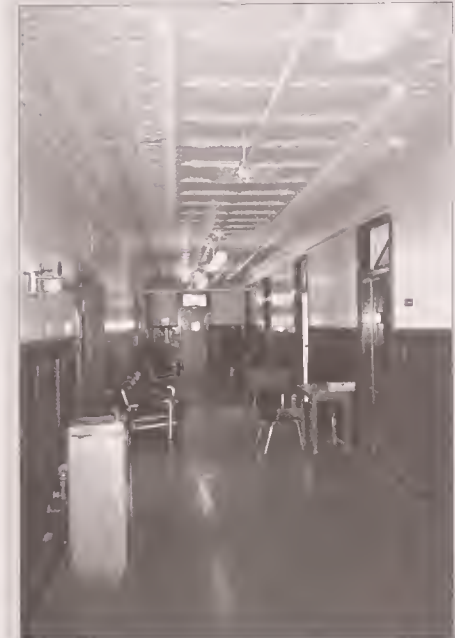
*Many of the Presidio office buildings have a basic floor plan consisting of a double-loaded corridor with office entrances on both sides. Transom windows above the doors allow natural light and ventilation into the corridors. The original floor-to-ceiling height in the corridors should be preserved and new ductwork installed in less important secondary spaces. Locations of original light fixtures are still evident in the pressed ceiling panels. When hanging fluorescent fixtures are removed, historically appropriate fixtures should be installed in the original locations.*

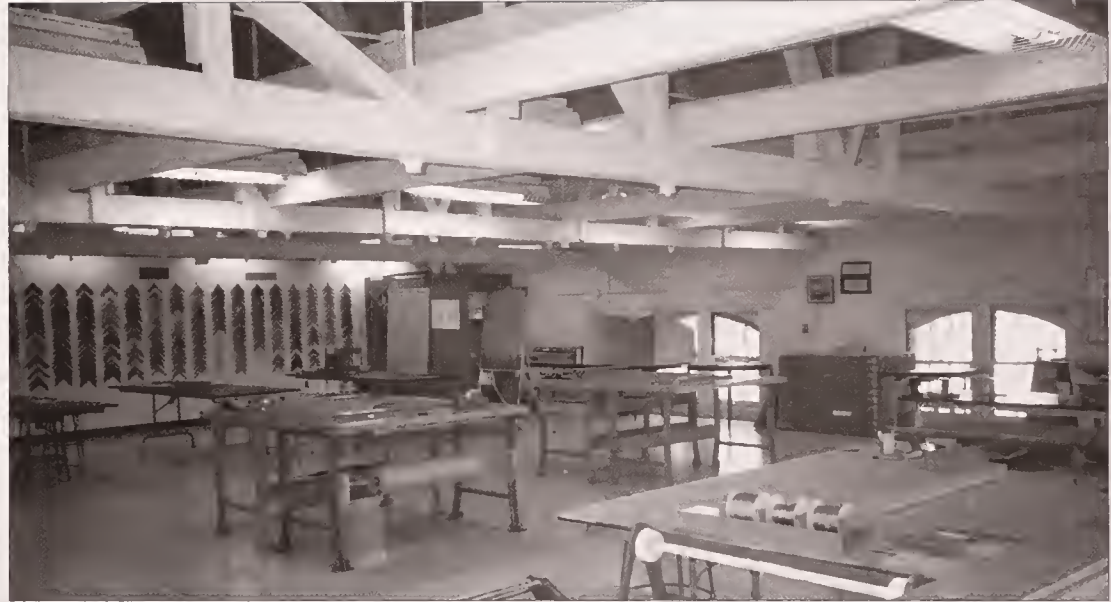
*Insertion of an intermediate floor is only suitable if it does not permanently damage the character-defining features of the space. Above is an example of an added floor that utilizes the open structure and height of the gymnasium space without interfering with the windows. However, this floor addition has radically altered the original open space and may not be reversible.*

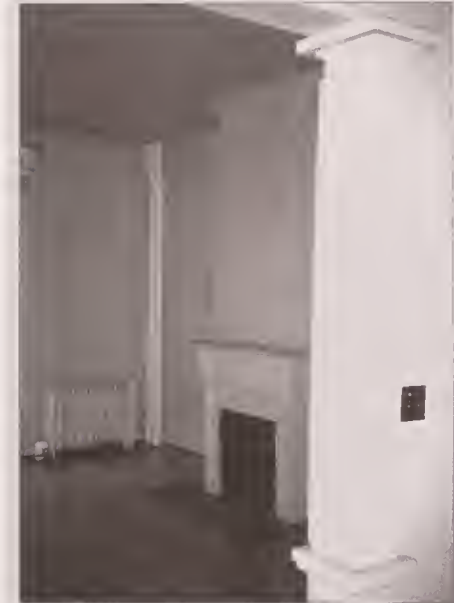
*In many residences, early steam or hot water heating systems remain, including radiators. These are frequently appropriate for continued use. In some cases, the addition of individual thermostats at the radiators may be necessary.*

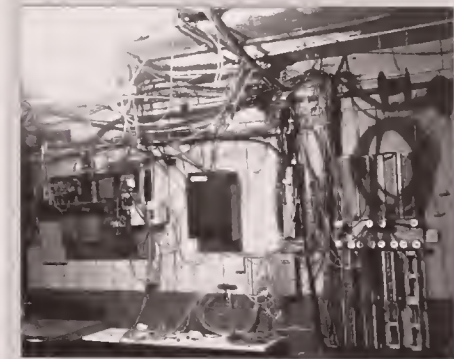
*Undisciplined wiring is a problem throughout the Presidio. It can pose fire and safety hazards and is frequently a visual distraction in significant spaces.*

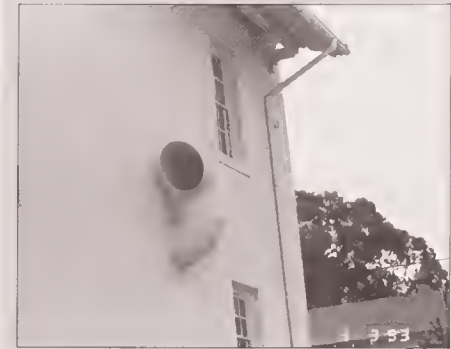
*Vestiges of defunct systems, such as this abandoned exhaust flue, can be character-defining features. The decision to keep or remove such elements should be made only after their significance is determined.*

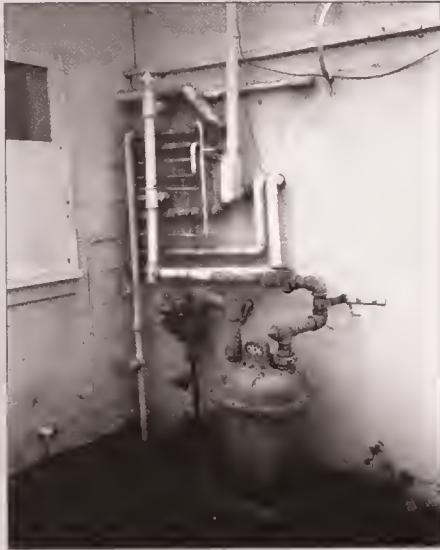
*The Presidio microclimate can cause rapid corrosion of exterior equipment and piping, particularly in exposed locations. Regular maintenance of all such equipment is critical.*

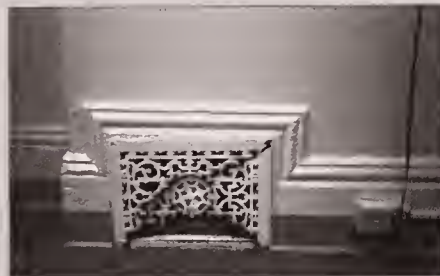
*Grilles such as this are found in many of the older buildings. They should be repaired and maintained even if they are no longer functional. Where possible, electrical receptacles such as the one shown should be replaced with better integrated elements: conduit could be concealed behind wood base.*

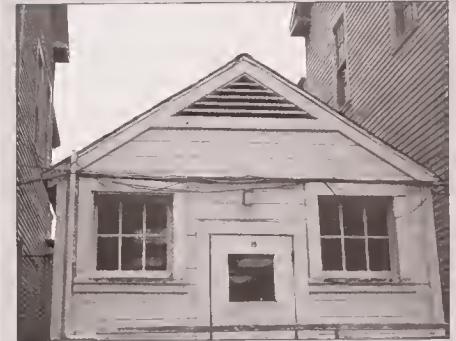
*The attic louver on this small building is a significant feature that serves an important function for the health of the building. Electrical wiring detracts from the building's historic exterior.*

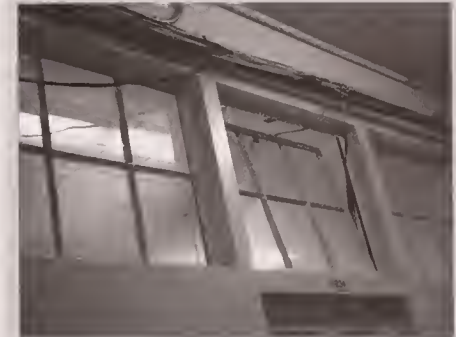
*Transoms, as well as skylights and clerestories, can provide needed light and ventilation and should be maintained in good working order. Note also the ad hoc method of wiring found throughout the Presidio.*

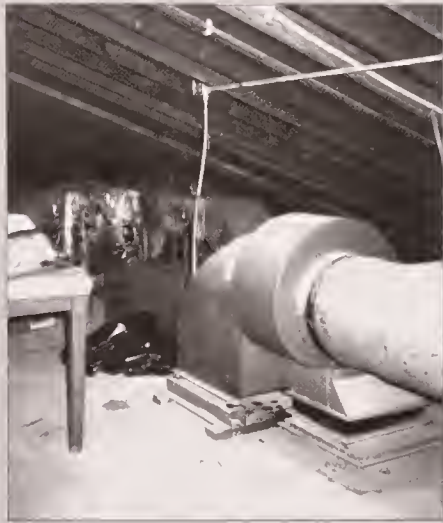
*Heating equipment is frequently located in attic spaces with inadequate ventilation. This situation must be remedied, by reactivating existing louvers or vents, installing new ones, or, if required, relocating equipment*

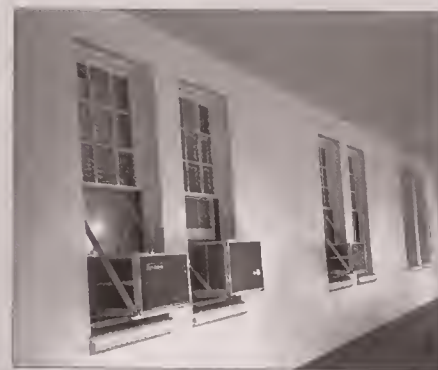
*Window air conditioning units are not appropriate for use in historic facades. These units should be removed and an alternative system for cooling, if needed, should be designed.*

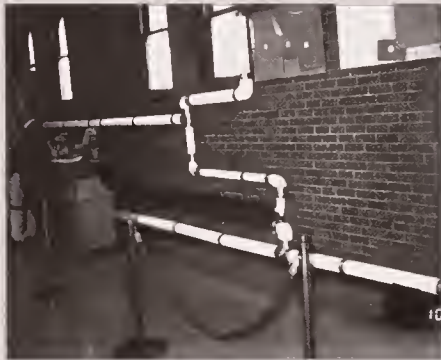
*These heating supply pipes have been installed in the lobby of a historic building. Their placement has had a major negative impact on the space. They should be removed and the system redesigned to allow a concealed, or less obtrusive distribution.*

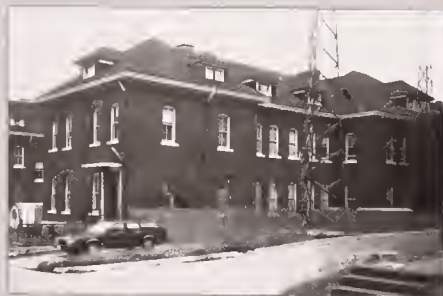
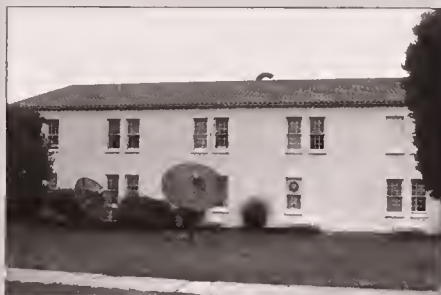
*The placement of antennas and satellite dishes must be done with regard to the historic context. The equipment shown above and below creates a strong negative impact on these important buildings; a less obtrusive location should be sought.*

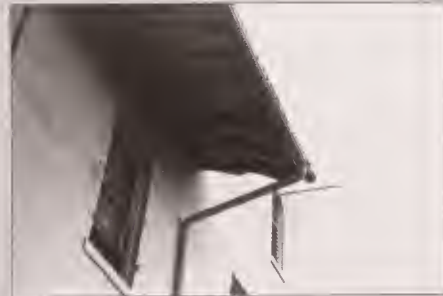
*Roof overhangs are a feature of many Presidio buildings. They perform a valuable energy conserving function, controlling summer sunlight and allowing windows to be used for ventilation during inclement weather.*

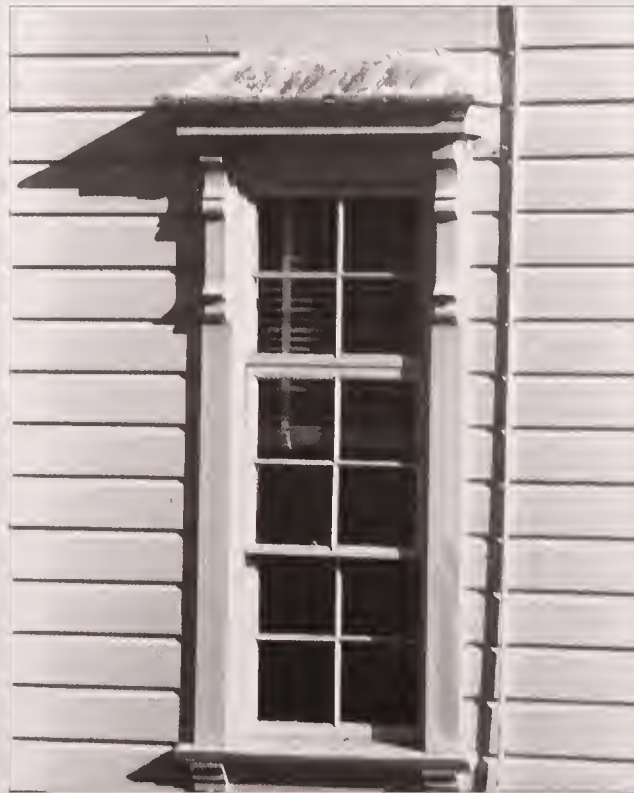
*All windows should be maintained to prevent air and water infiltration. Interior thermal control devices are normally preferred to exterior devices. An interior blind is used on the window shown at right with no adverse effect on the significant exterior features of the window.*

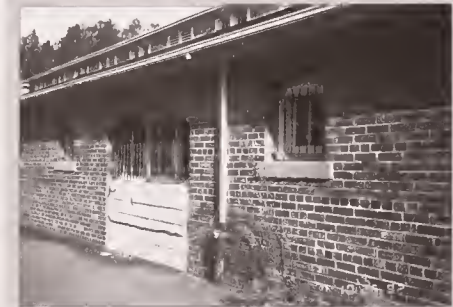
*Carefully study uninsulated brick buildings at the Presidio before proposing wall insulation. Their thermal mass may already have good heating and cooling properties, which would be compromised by insulation.*

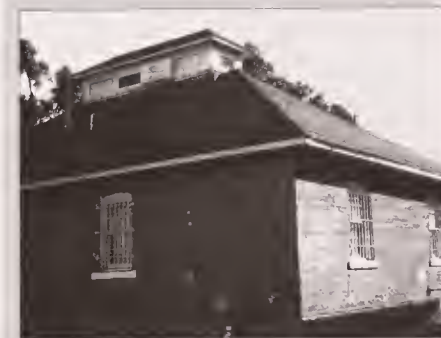
*Restoration and maintenance of the roof monitor shown, which provides both daylight and natural ventilation to the building interior, will both enhance the internal environment and reduce energy use.*

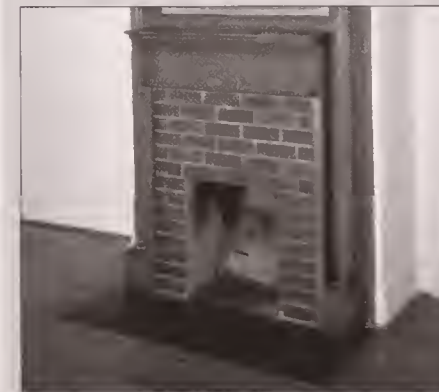
*Fireplaces with undampened chimneys are a major source of heat loss. Nonfunctional chimneys should be covered by removable caps.*

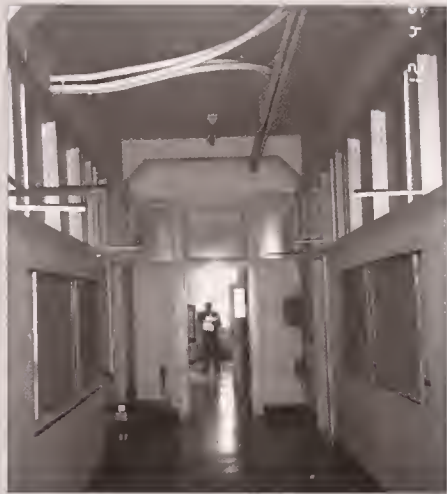
*Transoms are found in many Presidio buildings. Many of these have been painted or blocked and require restoration to fulfill their energy conserving function.*

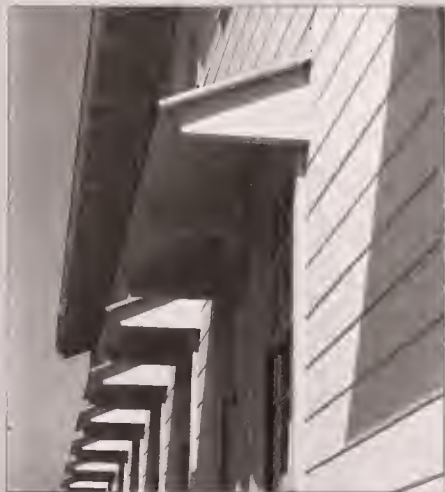
*Awnings can be appropriate devices for sunlight control, particularly on residences or modest, unornamented structures such as those shown here. They should be installed in a reversible fashion.*

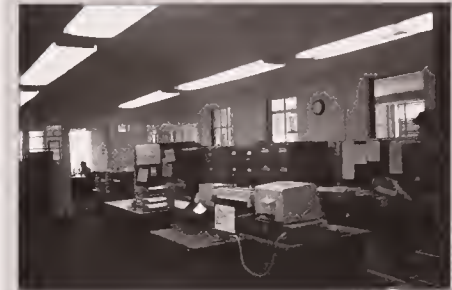
*Fluorescent lighting, as shown here, is energy efficient. However, with the natural light available, this space is clearly over-lighted. Substitution of task lighting for some of the overhead fixtures will increase efficiency and be more sympathetic to the historic space.*

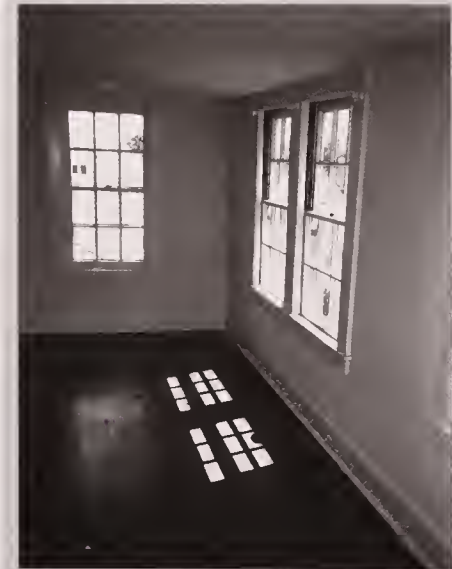
*Daylighting is an important feature of most Presidio buildings and should be maximized wherever possible. Basic incandescent lighting can be found throughout the Presidio, particularly in residences.*
